Mechanical Seal Plan Solution

Let see how Swagelok can help you solve leakage on seal pump

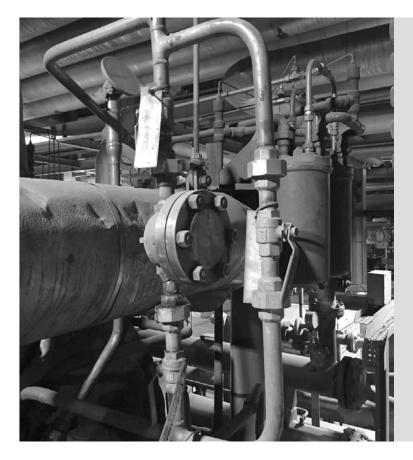
The customer's seal support system, featuring **multiple welded and threaded connections**, for a major Power Plant's boiler feed water pumps leaked excessively due to extreme pump vibration.

Before: Welded and threaded seal support system connection **leaked** due to extreame pump vibration.

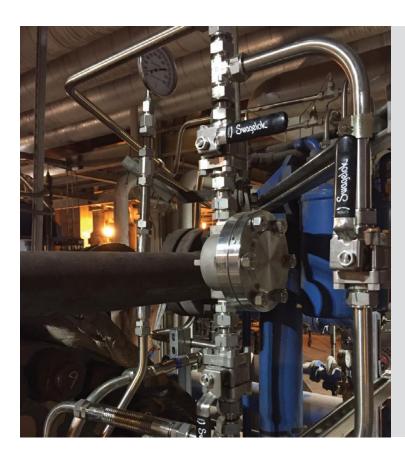
After:

Swagelok tube fittings, bent tubing, pre-assembled sub-systems and hoses effectively countered pump vibration to solve the leakage issue.

After extensive collaboration, including numerous site visits, with our customer, Swagelok applied its collective Fabrication System Design expertise to:

1. Reverse engineer new cooling and flushing in/out lines.

2. Deliver a **pre-fabricated Installation Work Package** that incorporated premier Swagelok tube fittings, bent tubing runs, pre-assembled sub-systems, and metal-core hoses.

Pump vibration was virtually eliminated, thus solving the seal support leakage issue. In addition, some of the tubing runs were left long to accommodate safer, easier, faster, and economical field installation by the site's maintenance technicians. We also provided onsite supervision to ensure optimum fit during the actual imprementation
