Product Test Report

PTR-5028

ASTM B117 Salt Spray Test of Swagelok® 8GB and 16GB Series General Service Ball Valves, Tested by Element Materials Technology

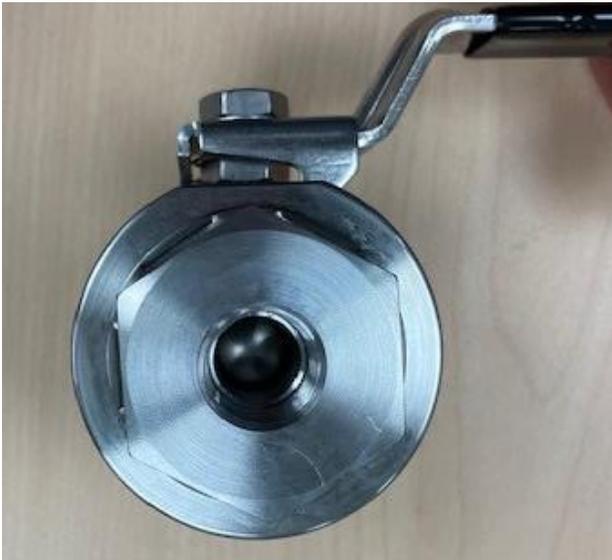
Before Test

SS-8GBF6 Valve 1 Discoloration

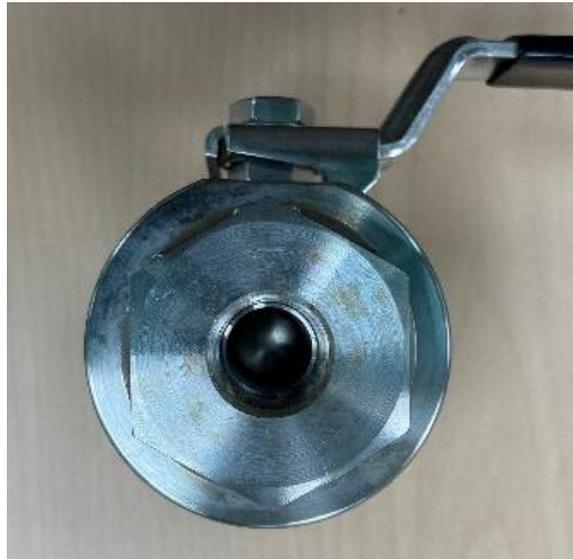
After Test

Time	Results
24 hours	No visible change.
72 hours	No visible change.
192 hours	No visible change.
336 hours	No visible change.
384 hours	No visible change.
504 hours	Light corrosion forming on the outside body and end screws was observed.
672 hours	Evidence of isolated spots of red rust corrosion was visible on both samples. The total corrosion was estimated at less than 5% of the total surface area of each part.

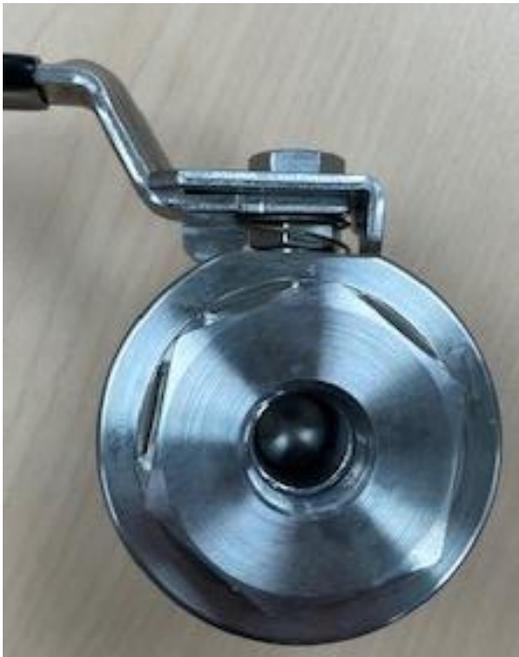
Before Test

SS-8GBF6 Valve 2 Discoloration

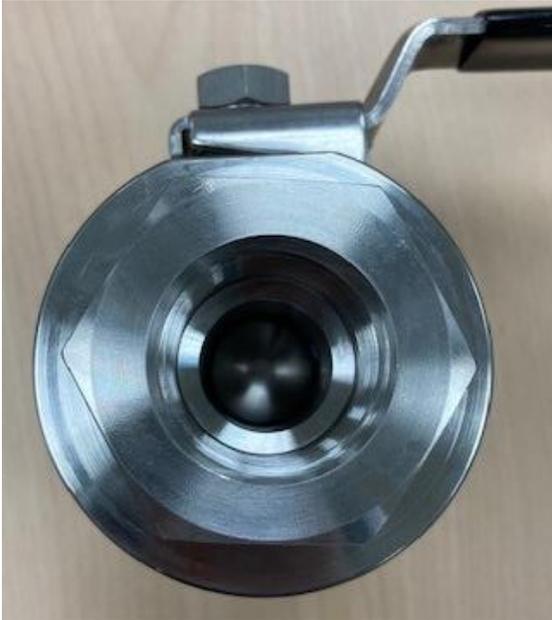
Before Test

SS-16GBF16 Valve 1 Discoloration

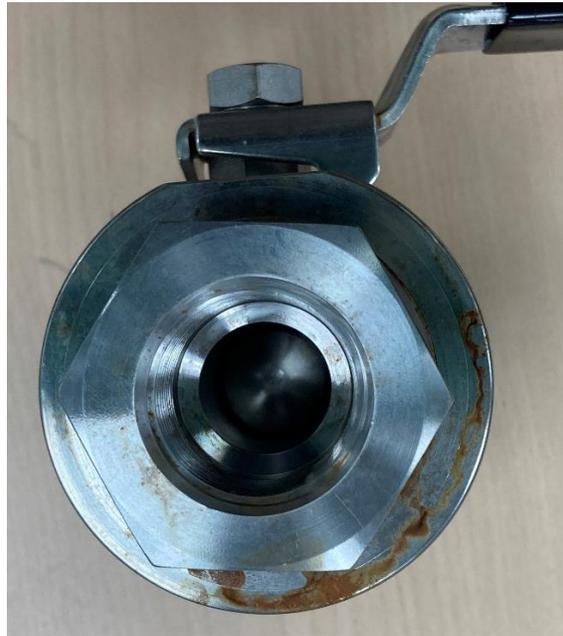
After Test

Time	Results
24 hours	No visible change.
72 hours	No visible change.
192 hours	No visible change.
336 hours	No visible change.
384 hours	No visible change.
504 hours	Light corrosion forming on the outside body and end screws was observed.
672 hours	Evidence of isolated spots of red rust corrosion was visible on both samples. The total corrosion was estimated at less than 5 to 10% of the total surface area of each part.

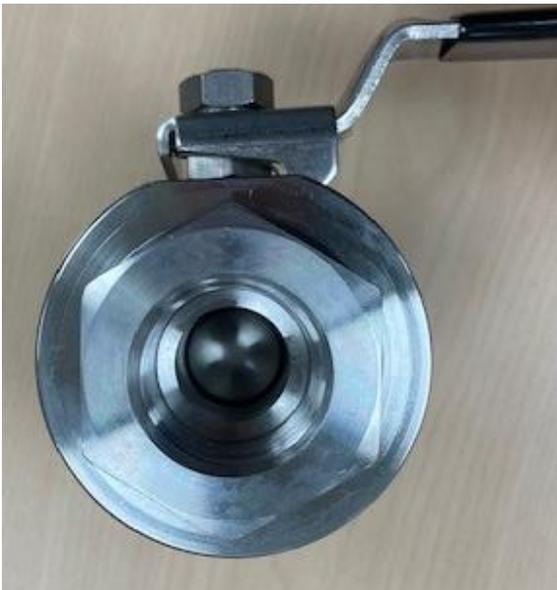
Before Test

SS-16GBF16 Valve 2 Discoloration
