PTR-4183

Chloride Stress Corrosion Cracking (CSCC) Test of 316 Stainless Steel Swagelok® Tube Fitting Engineered Combinations Using 65°C Cyclic Salt Spray with Substitute Ocean Water

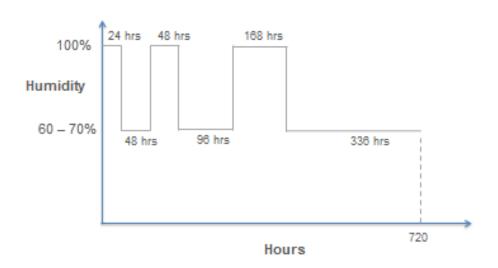
Figure 1: Cyclic humidity corrosion salt spray schedule

Dual Cycle Humidity Test – at 65°C

- 6. Samples were pressurized with water to the test pressure and held at that pressure throughout the CSCC test.
- 7. The chamber temperature was elevated to 65°C (149°F) and the following salt spray schedule, derived from SAE J2334 and ASTM B117, was initiated:

- a. continuous salt spray maintained at 65°C for 24 hours
 - b. salt spray turned off, 60% to 70% relative humidity maintained at 65°C for 48 hours
 - c. repeat step a for 48 hours

- d. repeat step b for 96 hours
 - e. repeat step a for 168 hours
 - f. repeat step b for 336 hours, for a schedule total of 720 hours (see **Figure 1**)
